# **INDOOR AIR QUALITY ASSESSMENT**

**North Reading High School  
189 Park Street  
North Reading, Massachusetts**

Prepared by:  
Massachusetts Department of Public Health  
Bureau of Environmental Health Assessment  
May, 2001

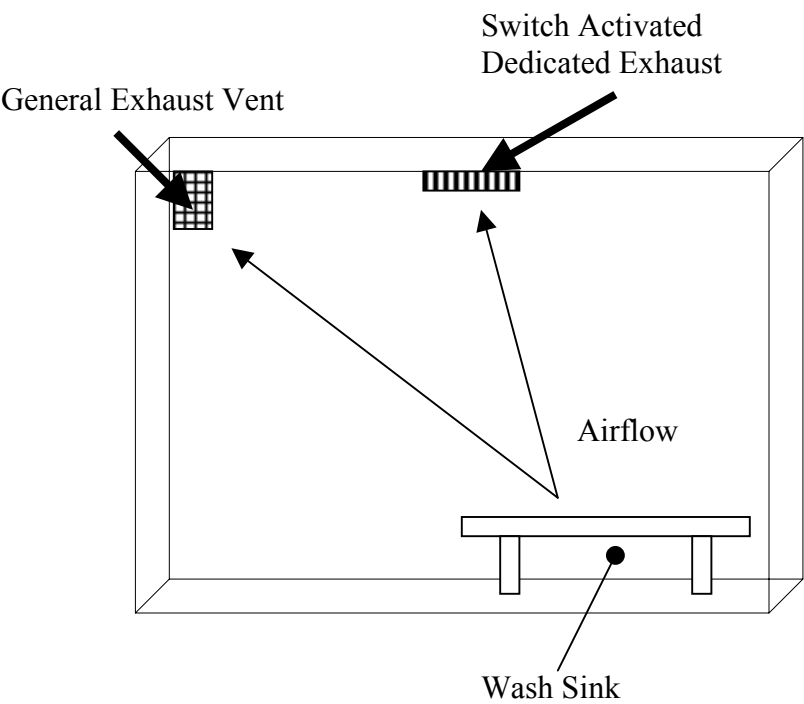
**Figure 2**

The dark room uses a number of developing chemicals that create odors in this room. Photographic chemicals contain volatile organic compounds (VOCs), which can be irritating to the eyes, nose and throat. Local exhaust ventilation exists in this room, which is activated by a switch. Local exhaust vents should be located at the level of the wash sink and developing pans to draw odors away from users. The location of the exhaust fan in the ceiling will tend to draw odors into users of the wash sink and developing pans (see Figure 2). There also appears to be an exhaust vent connected to the school's general exhaust system in this room. Under certain conditions, VOCs can be a fire hazard and need to be exhausted from the building by a system that is separate from the main exhaust ventilation system of the school. Darkroom vapors can be entrained by the exhaust vent and introduce these pollutants to other sections of the school connected to ductwork of this vent.

18. Consider reconfiguring the photo developing sink and local exhaust ventilation in the darkroom to draw chemical vapors away from occupants. Consider consulting a ventilation engineer to assess whether the existing exhaust mechanical ventilation system can be adapted.

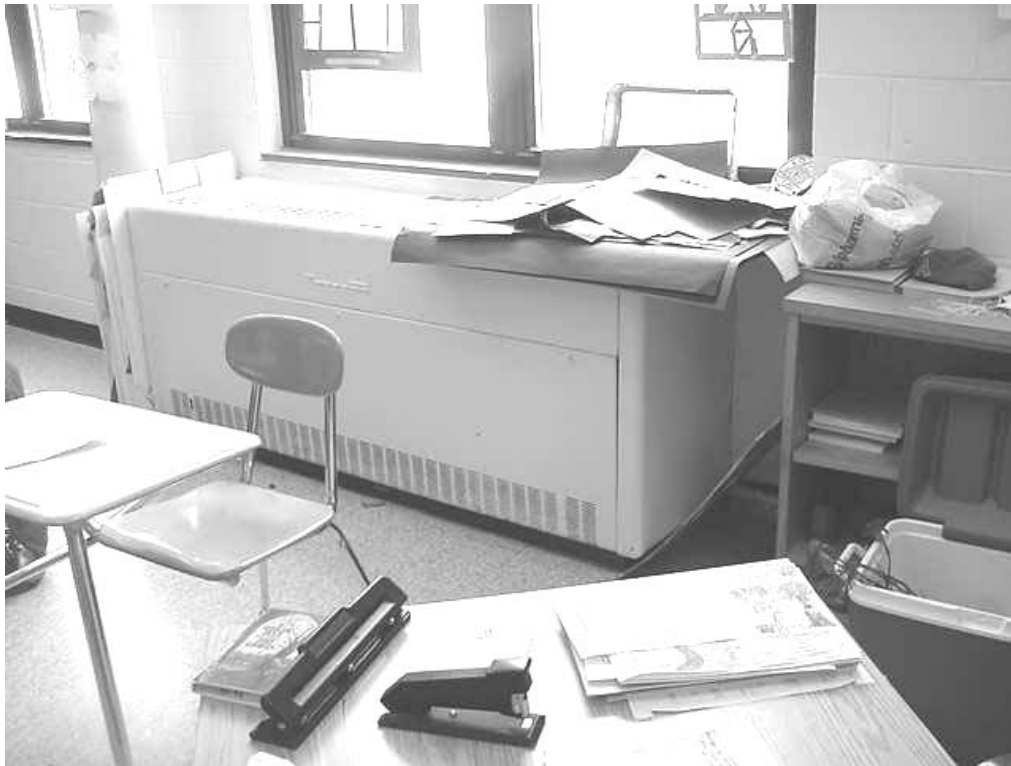
**Picture 1**

Ventilation in classrooms and in the cafeteria is provided by a unit ventilator (univent) system (see Picture 1). Univents are designed to draw air from outdoors through a fresh air intake located on exterior walls of the building and return air through an intake located at the base of each unit ([see Figure 1](#)). Fresh air and return air are

mixed, filtered, heated and provided to classrooms through a fresh air diffuser located in the top of the unit. Univents were deactivated in many classrooms. Obstructions on and around univents, such as books, papers and posters on air diffusers, as well as bookcases, tables and desks in front of return vents, were also seen in a number of classrooms. To function as designed, univent air diffusers and returns must remain free of obstructions. Importantly, these units must be activated and allowed to operate during hours of school occupation. Ventilation to common areas (e.g., auditorium, gymnasium & library) is provided by rooftop air handling units (AHUs).

**Classroom Univent: Note Items on Top**

6. Remove all blockages from univents and exhaust vents.
7. For buildings in New England, periods of low relative humidity during the winter are often unavoidable. Therefore, scrupulous cleaning practices should be

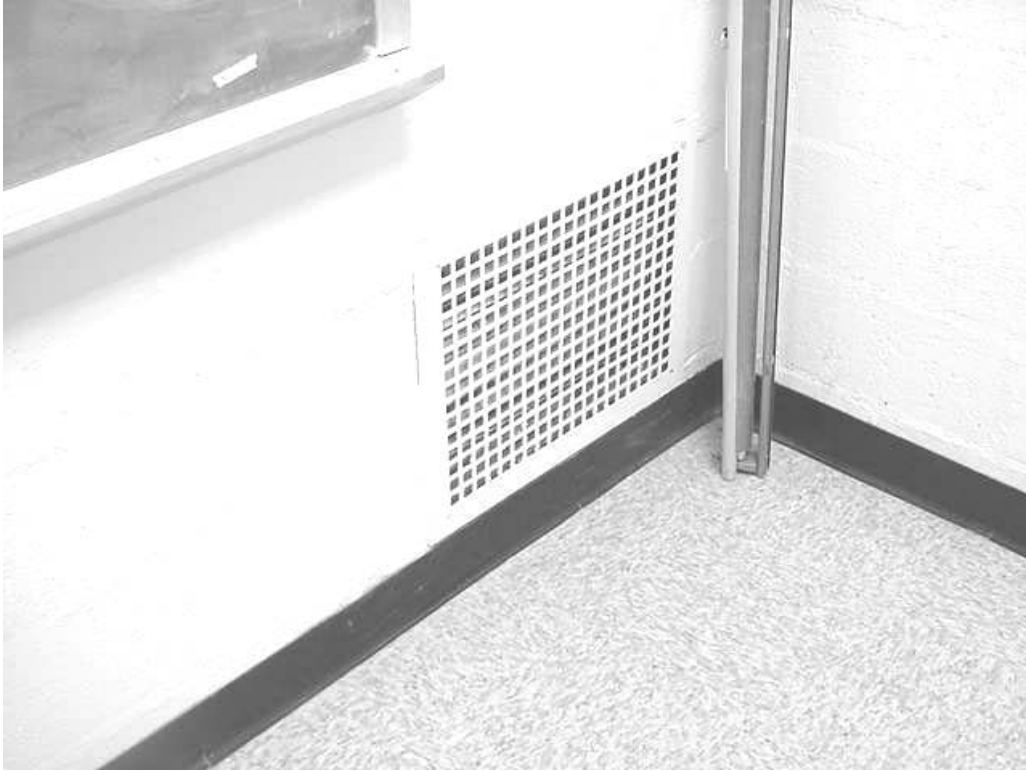
**Picture 2**

The mechanical exhaust ventilation system for classrooms consists of ducted, grated wall vents (see Picture 2); many of which were obstructed by furniture, storage carts, shelves and other items (see Picture 3). Exhaust vents were not drawing air in a number of classrooms, which can indicate that the exhaust ventilation was turned off, or that rooftop motors were not functioning. BEHA staff and Mr. Hardacker examined exhaust motors on the roof. It was determined that a number of these motors were not functioning or did not have fan belts (see Table 10 “Roof Notes”). Complaints of odors/backdrafts from the exhaust vents were expressed to BEHA staff in several areas: specifically in classroom A104, the boys’ locker room and in a number of restrooms. While no odors were detected on the day of this assessment, backdrafting of air from exhaust vents was noted.

**Classroom Exhaust Vent**

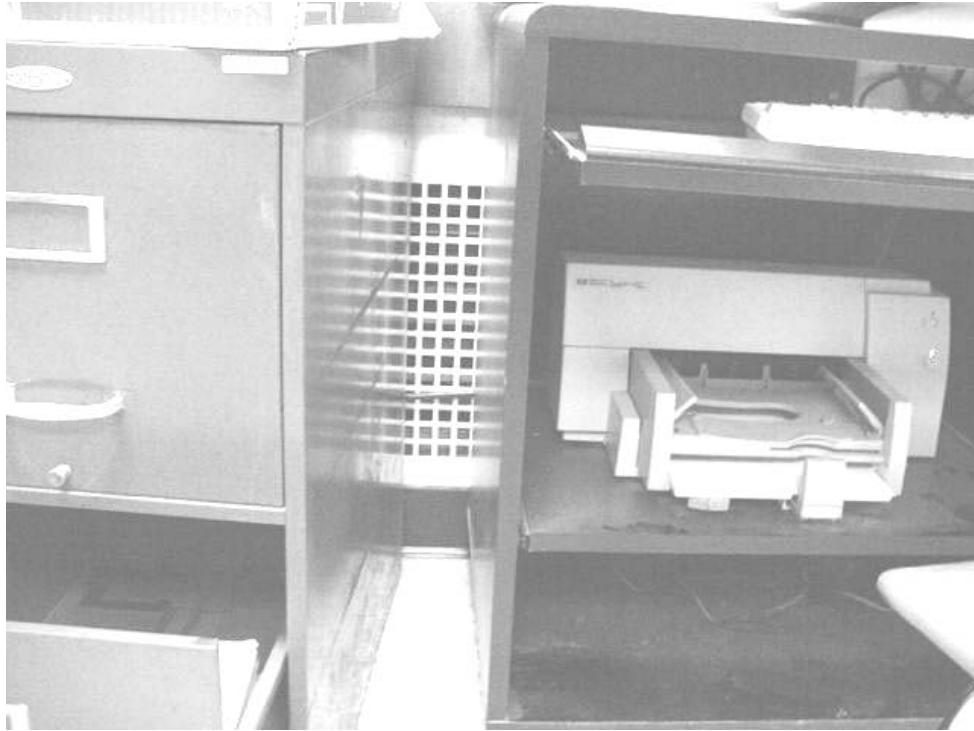
**Picture 3**

**Exhaust Vent Blocked by Items**

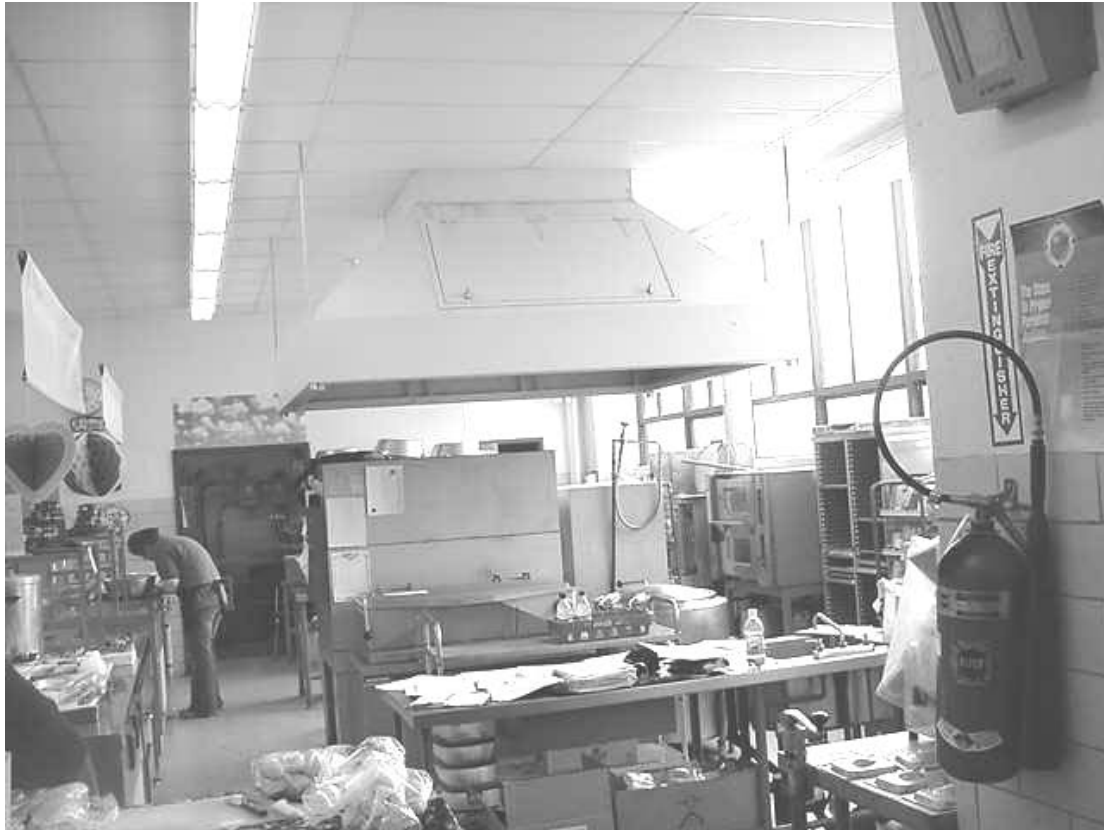
**Picture 4**

No exhaust ventilation within the cafeteria could be identified. It appeared that exhaust ventilation was provided for the cafeteria by a large exhaust hood centrally located in the kitchen (see Picture 4). When activated the exhaust hood creates negative pressure in the kitchen which draws air from the cafeteria through a series of passive vents (see Picture 5) into the kitchen and out the exhaust hood. On the day of the

assessment the kitchen hood was deactivated, therefore no exhaust ventilation was being provided for either the kitchen or cafeteria.

**Kitchen Exhaust Hood**

5. Ensure kitchen vent hood is activated to provide exhaust ventilation to the kitchen/cafeteria. Examine the feasibility of provide independent exhaust ventilation to the cafeteria.

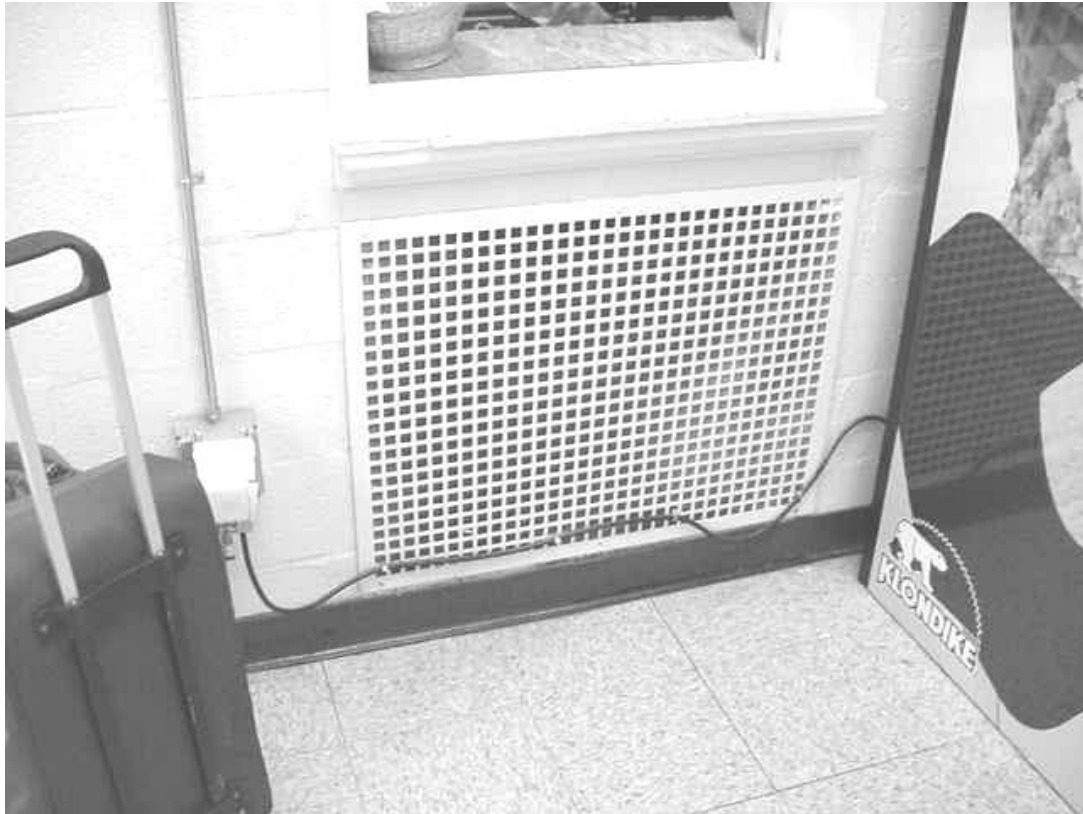
**Picture 5**

**Passive Vent in Cafeteria**

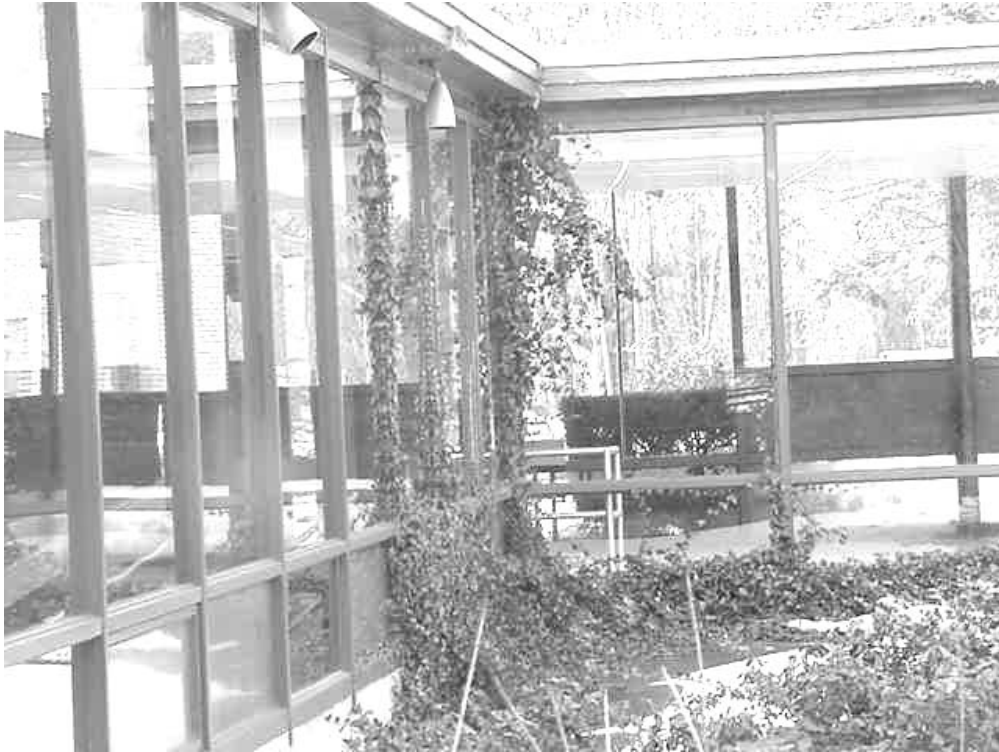
**Picture 6**

discovered. Vines were growing on the exterior walls of the building, within the courtyard (see Picture 6). The tendrils of vines can work their way into mortar and brickwork causing cracks and fissures. Rainwater can also accumulate between vines and brickwork, which can lead to water penetration undermining the integrity of the building envelope.

**Clinging Vines in School Courtyard**

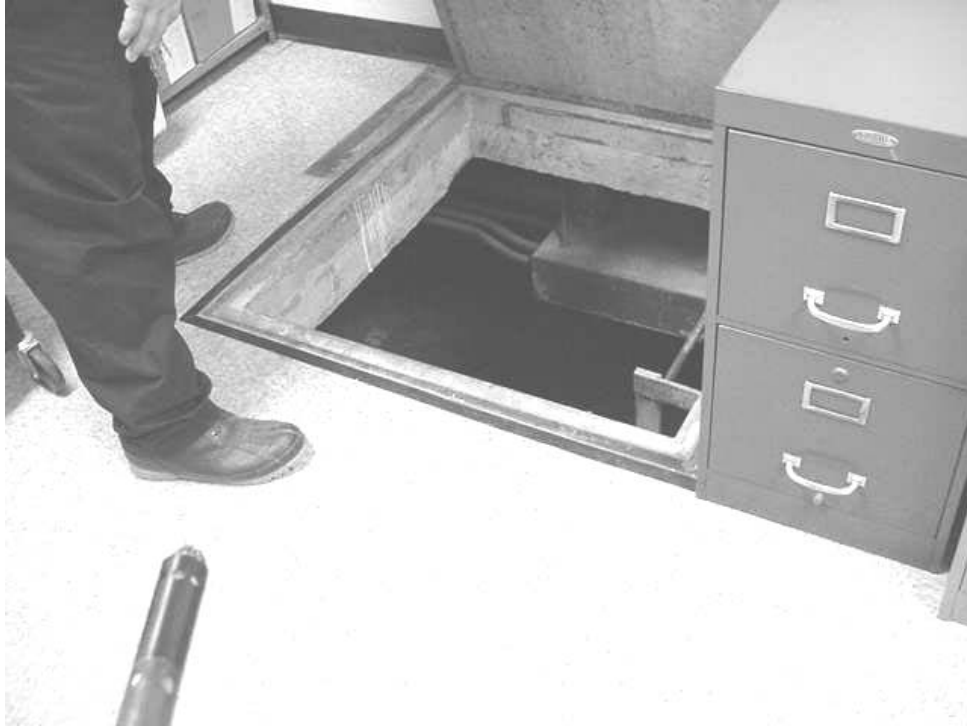
**Picture 7**

There is a basement/crawlspace beneath the school which has a dirt floor. The crawlspace can be entered through the receiving room (A111), the stage area of the auditorium, or hatchways in various locations (see Picture 7). The soil and other materials within the crawlspace can support mold growth when exposed to moisture. Materials that can support mold growth, include carpets (which were reportedly placed in the crawlspace to keep dust down), its dirt floor, pipe insulation, and stored items. Active leaks were also noted in the crawlspace from holes/expansion joints in the foundation, with pooling water located, along the northern wall of A-wing crawlspace. Pooling water can become stagnant and become a source for bacterial/algal growth/odors. The American Conference of Governmental Industrial Hygienists (ACGIH) recommends that water damaged materials be dried with fans and heating within 24 hours of becoming wet (ACGIH, 1989). If moistened materials are not dried within this time frame, mold growth may occur.

**Hatchway Entrance to Crawlspace**

21. Relocate bus parking area or have busses shut off engines after five minutes as required by Massachusetts General Laws 90:16A.
22. Remove carpets from crawlspace and replace with a non-porous, water-resistant material (e.g., rubber or plastic).

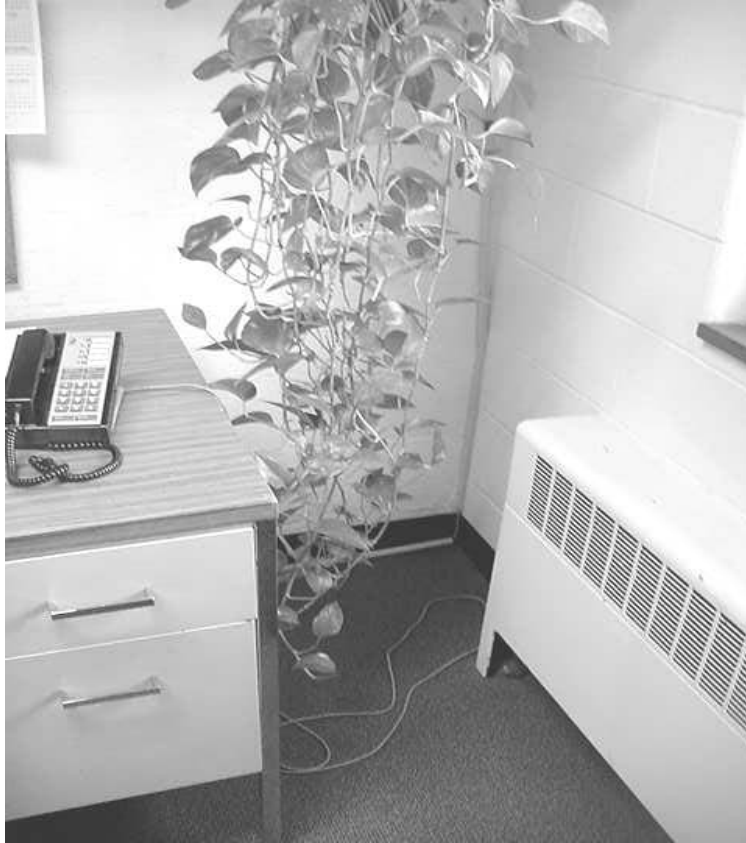
**Picture 8**

Plants were noted in several classrooms and can be a source of pollen and mold. Pollen and mold can be respiratory irritants to some individuals. Plants should be properly maintained and equipped with drip pans. Plants should also be located away from univents to prevent the aerosolization of dirt, pollen or mold. A large hanging plant was located over carpet in the main office (see Picture 8). If over-watering occurs, the carpet can get wetted, which can result in potential for mold growth (see above).

**Hanging Plant over Carpet**

9. Keep plants away from univents in classrooms. Ensure plants have drip pans and examine drip pans for mold growth. Disinfect areas with an appropriate antimicrobial where necessary.

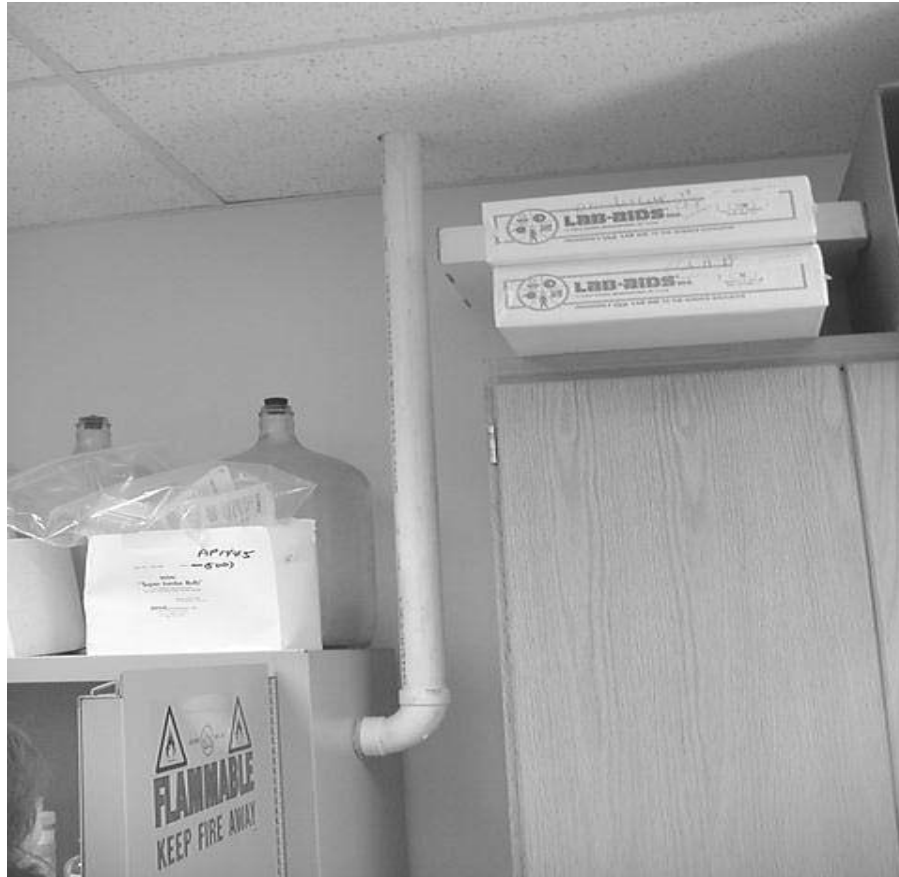
**Picture 9**

Several other conditions were noted during the assessment, which can affect indoor air quality. Of note is the condition of the flameproof cabinets in each of the three chemical storerooms within science classrooms in C-wing. Each of these cabinets is ducted with PVC pipe to a rooftop exhaust vent (see Picture 9). No draw of air was detected by BEHA staff at the time of the inspection. The National Fire Prevention Association (NFPA) does not require venting in flammable storage cabinets, however, if venting is done, it must be vented directly outdoors and in a manner not to compromise the specific performance of the cabinet (NFPA, 1996). If air back-flow from outdoors into the cabinet through the venting occurs, off-gassing chemicals can be forced from the flammable storage cabinet into the storeroom. The installation of a damper or mechanical exhaust fan should prevent air back-flow into the cabinet.

**Flammables Cabinet Ducted to Roof by PVC Pipe**

15. Prohibit smoking in this building in accordance with Massachusetts law (M.G.L. Chapter 270, Sec. 22).
16. Inspect flammable cabinet venting system to ensure it is equipped with a damper or mechanical exhaust motor to prevent backdrafting into cabinet. If neither mechanism is present, remove vent pipe altogether and seal hole to make airtight.

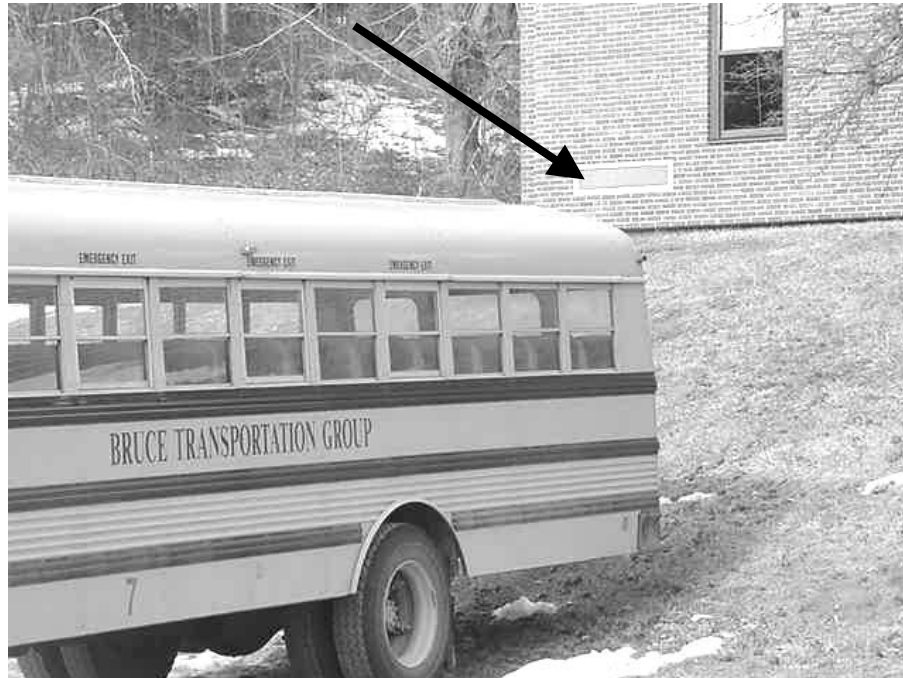
**Picture 10**

Complaints related to vehicle exhaust infiltration were expressed to BEHA staff. Located adjacent to the south side of C-wing is the bus parking lot for the North Reading school system (see Picture 10). BEHA staff received several complaints concerning vehicle exhaust odors in C-wing. Idling buses in the parking lot near the school can result in vehicle exhaust entrainment by the mechanical ventilation system and open windows under certain weather conditions; which may, in turn, provide opportunities for exposure to combustion products such as carbon monoxide. At the time of the assessment no vehicle exhaust odors or measurable levels of carbon monoxide were detected within the school. M.G.L. chapter 90 section 16A prohibits the unnecessary

operation of the engine of a motor vehicle for a foreseeable time in excess of five minutes (MGL. 1996).

**School Bus Parking: Note Close Vicinity to Univent Air Intake**

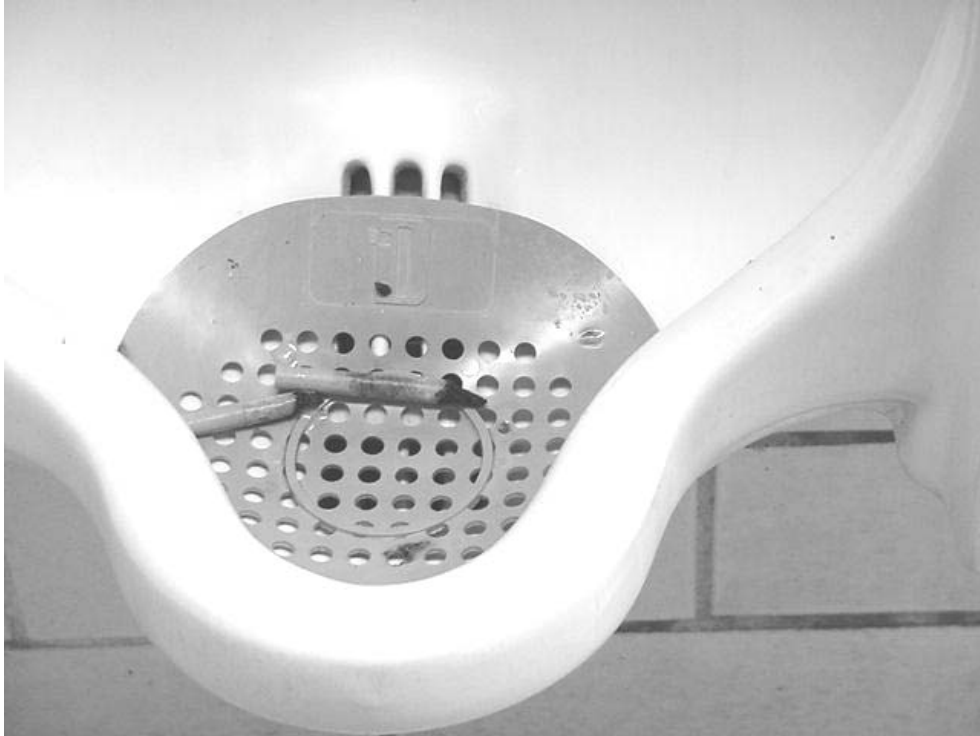
**Picture 11**

A number of cigarette butts/ashes were observed in the student restrooms (see Picture 11). Environmental tobacco smoke can have a marked effect on indoor air quality. The most effective method of preventing exposure to environmental tobacco smoke is to have smoke-free buildings. M.G.L. Chapter 270, Sec. 22 prohibits smoking in public buildings, except in an area which has been specifically designed as a smoking area (M.G.L., 1987).

**Cigarette Butts in Urinal**

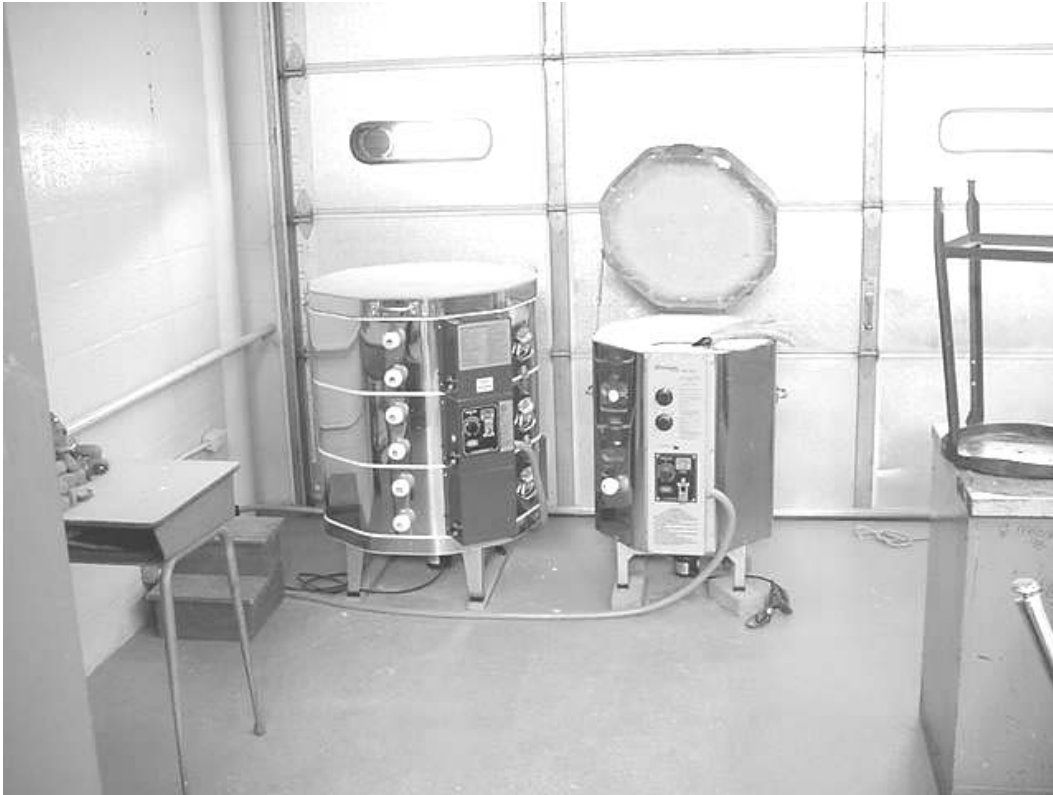
**Picture 12**

The art room contains two unvented pottery kilns (see Picture 12). Kiln exhaust may contain corrosive, hazardous and irritating materials including chlorine, sulfur dioxide and carbon monoxide, and should be provided with dedicated local exhaust ventilation (McCann, 1985). Without local exhaust ventilation, pollutants produced by the pottery kiln can penetrate into adjacent occupied rooms in the school.

**Unvented Kilns in Art Room**

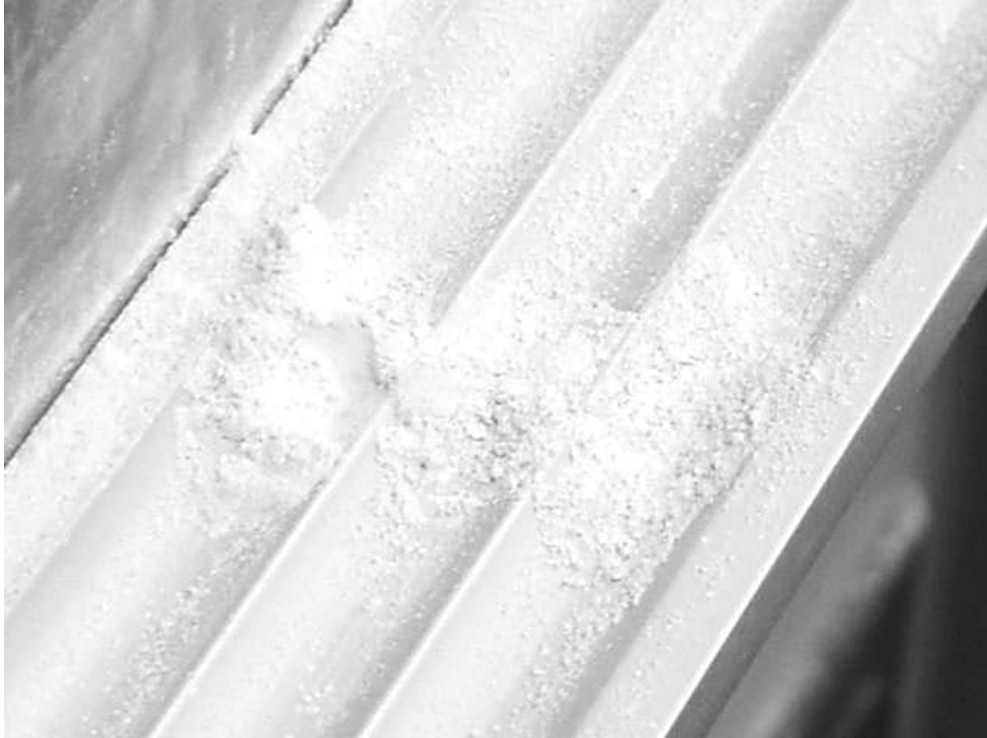
**Picture 13**

Accumulated chalk dust was observed in several classrooms (see Picture 13). Chalk dust is a fine particulate, which can become easily aerosolized and serve as an eye and respiratory irritant. Utility holes around pipes and missing ceiling tiles were also observed in several areas of the school. Open utility holes can provide a means of egress for odors, fumes, dusts and vapors between rooms and floors. The movement of ceiling tiles can introduce dirt, dust and particulate matter into occupied areas of the school.

**Accumulated Chalk Dust in Classroom**

12. Clean chalkboards and trays regularly to prevent the build-up of excessive chalk dust.
  13. Relocate or consider reducing the amount of materials stored in classrooms to allow for more thorough cleaning of classrooms. Clean items regularly with a wet cloth or sponge to prevent excessive dust build-up.

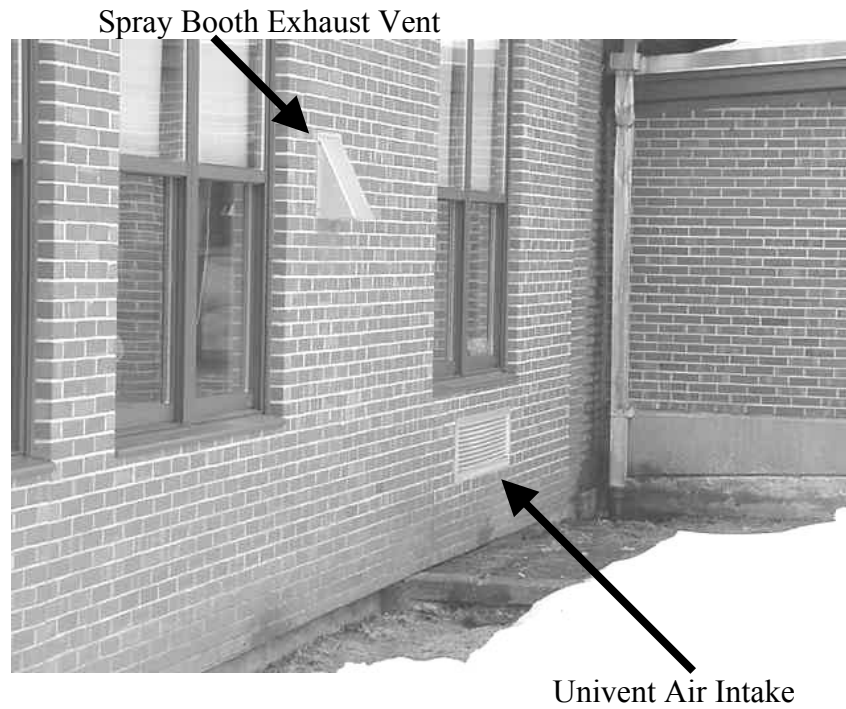
**Picture 14**

The art room contains a spray booth that is vented to the outside. Located in close proximity to the spray booth exhaust vent is the art room's univent air intake (see

Picture 14). In its current configuration it is possible for materials used in the spray booth to be entrained into the univent air intake under certain wind and weather conditions.

**Proximity of Spray Booth Exhaust Vent to Univent Air Intake, Note Spray Booth Vent Forces Exhausted Materials Down**
